Gregg A. Helvey, DDS, MAGD, Ltd

Crowns & Veneers: Dental Mistakes Cause Physical Pain, Speech Problems, and Concerns for Appearance

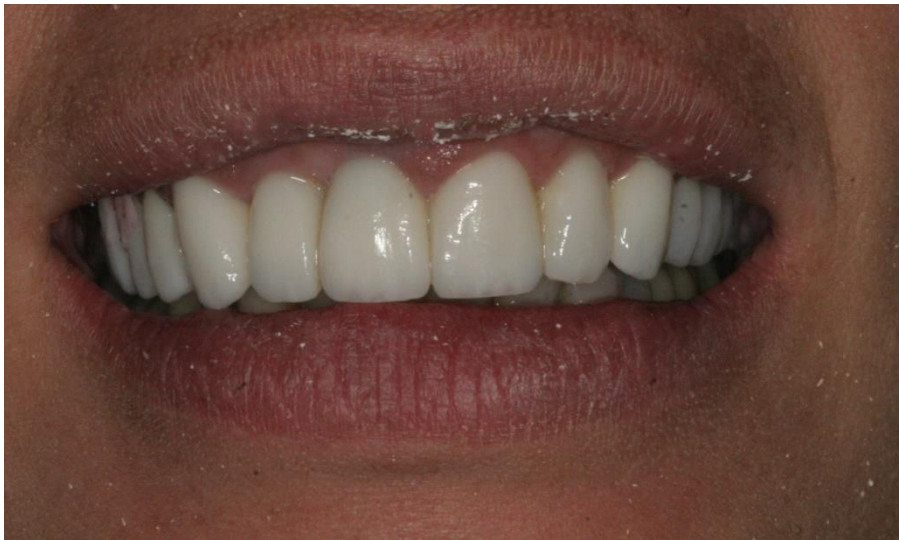
During my initial examination I found her having difficulty in pronouncing “f”, “v” and “s” sounds. It was noted during phonetic testing that because of the increased length of the maxillary anterior teeth, the incisal edges were encroaching on her lower lip causing problems with the pronunciation of the aforementioned sounds.

(Fig. 1. Initial appointment, frontal view the crowns and veneers placed by Dr. R. Note the chipped porcelain edge on the left lateral incisor (tooth next to the left front tooth) The 2 front teeth measured 12 millimeters (norm for a female is 10 mm). Her teeth before Dr. R's treatment, measured 10 millimeters.)

I then discussed how shortening the length of the crowns could possibly solve her phonetic problem and prevent further fracturing of the ceramic crowns and veneers. The reduction in length would also resolve the chipped veneer problem since it was located on the edge of the crown and that chipped portion would be removed as the length of the crowns shorten. As far as the problem with the crowns being too white, the only solution was re-place them using a more natural shade of porcelain.

I then recommended that she return to Dr. R with the information we discussed and ask that he alter the length.

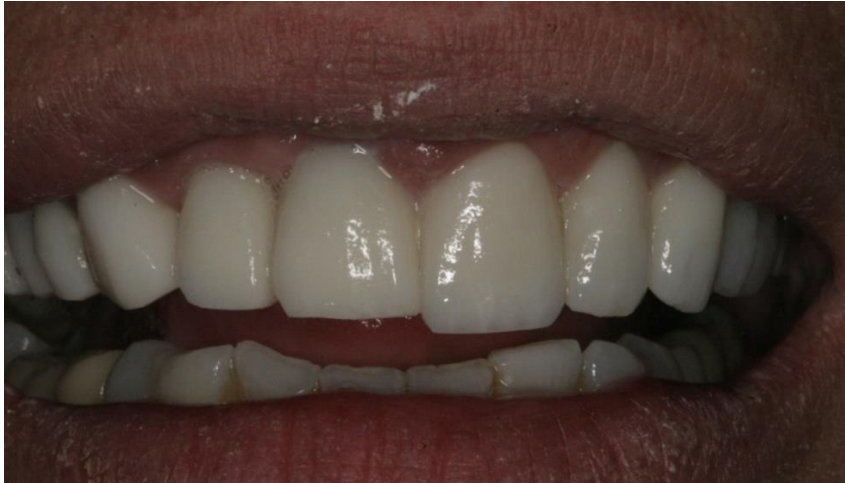
Fig. 2. The view depicts the amount of reduction that was made and the comparison of altered tooth lengths.

Patient returned to the office on 10/3/12 to begin the first phase of treatment. The initial reduction of the crowns was made in the right maxillary quadrant. The right central incisor was reduced in length to 10 millimeters (Fig. 2). The reduction in length of the remaining crowns was

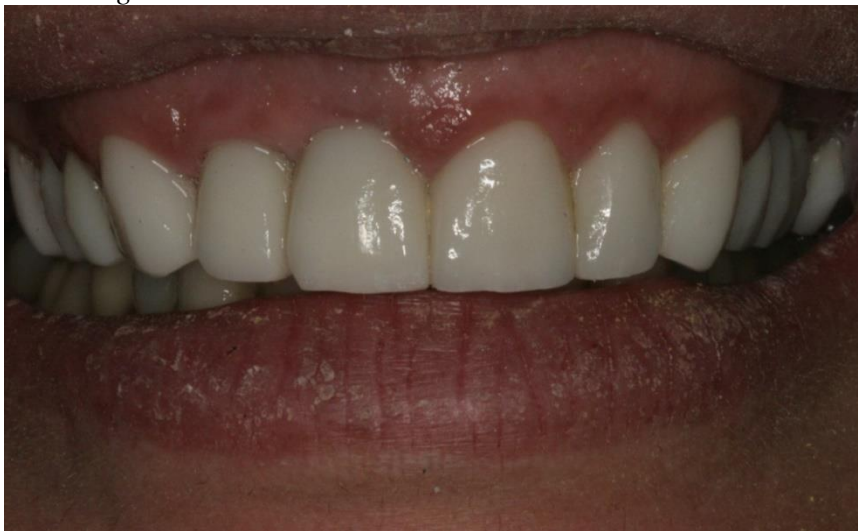
Fig. 3 Frontal view after the length of the all crowns had been reduced.

subsequently performed to the maxillary 1st molar. The same process was then completed on the left maxillary quadrant (Fig. 3).

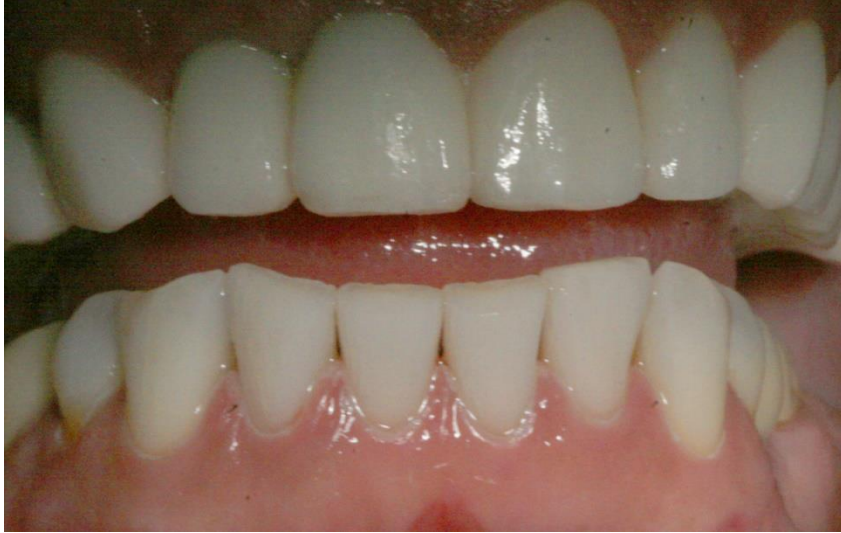
I also found a lack of posterior separation when her lower jaw moved in a protrusive movement due to the lack of anterior guidance. This means that when her lower jaw was moved to an edge-to-edge position, her back teeth did not separate. Her lower anterior teeth were severely worn and lacked the necessary length for the separation of the posterior teeth to occur. I asked Patient if Dr. R had recommended treatment addressing this situation. She did not remember if this problem was discussed.

Fig. 4. The anterior teeth prior to placement of the bonded mock-up depicting the worn lower anterior teeth.

Using a vacuum-formed stent, the mock-up was then placed on her lower anterior teeth (Fig. 4 and 5).

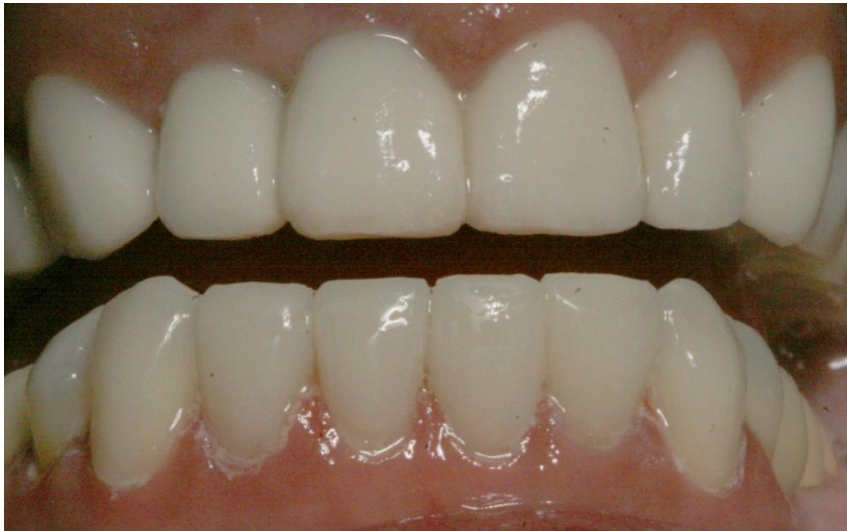
Fig. 5. The mock-up bonded in place to simulate the shape, contour and length of the final restorations.
