# Death at the End of a Hose

*How one man's honest mistake cost another man his life, and grief for several companies.*

BY STEVEN M. BARSKY

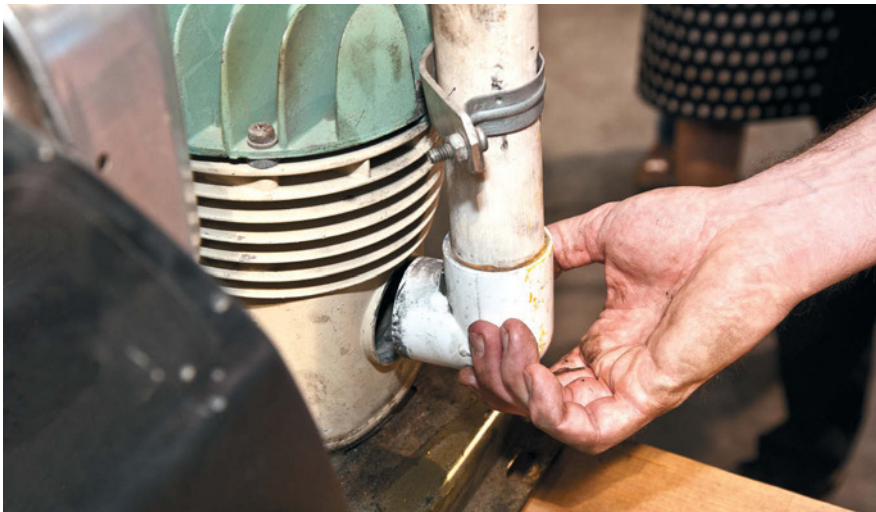
The connection between the snorkel and the compressor was not secure, which would allow carbon monoxide to freely enter the compressor.

i.e. “snorkel,” the connection between the snorkel and the compressor was not secure, allowing carbon monoxide to freely enter the compressor.

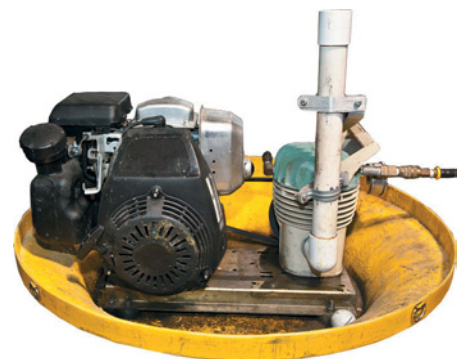
The hookah diving system that was provided by the golf ball diving company to the diver who died.

When the engine on Mike's hookah system died, he purchased a new one from a hardware store, without giving it too much thought. After all, all small engines are alike, aren't they? Unfortunately not, for although their footprint was identical, the engine exhaust on the new engine was located on the opposite side when compared to the prior engine used in the system. This placed the exhaust for the engine less than twelve inches away from the compressor intake.

compression of carbon monoxide along with the diver's breathing air. The snorkel on his compressor was missing an extension piece, which he may not have even realized needed to be there. In addition, Mike had never bothered to have the air from the compressor tested for purity.

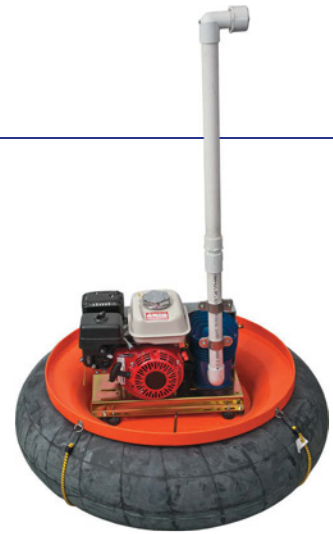
A properly configured hookah diving system looks like this. Note the tall white air intake or “snorkel” used to provide air to the compressor. This type of system is not considered acceptable for commercial diving under ADCI standards.
